ATA AIRLINES, INC.

{CPCP} LOWER LOBE INTERIOR, BS 396-BS 560, S17 (L/R) - BL 0.0

W/C NUMBER: 211I5375
DATE:
W/O:
JAC CODE:

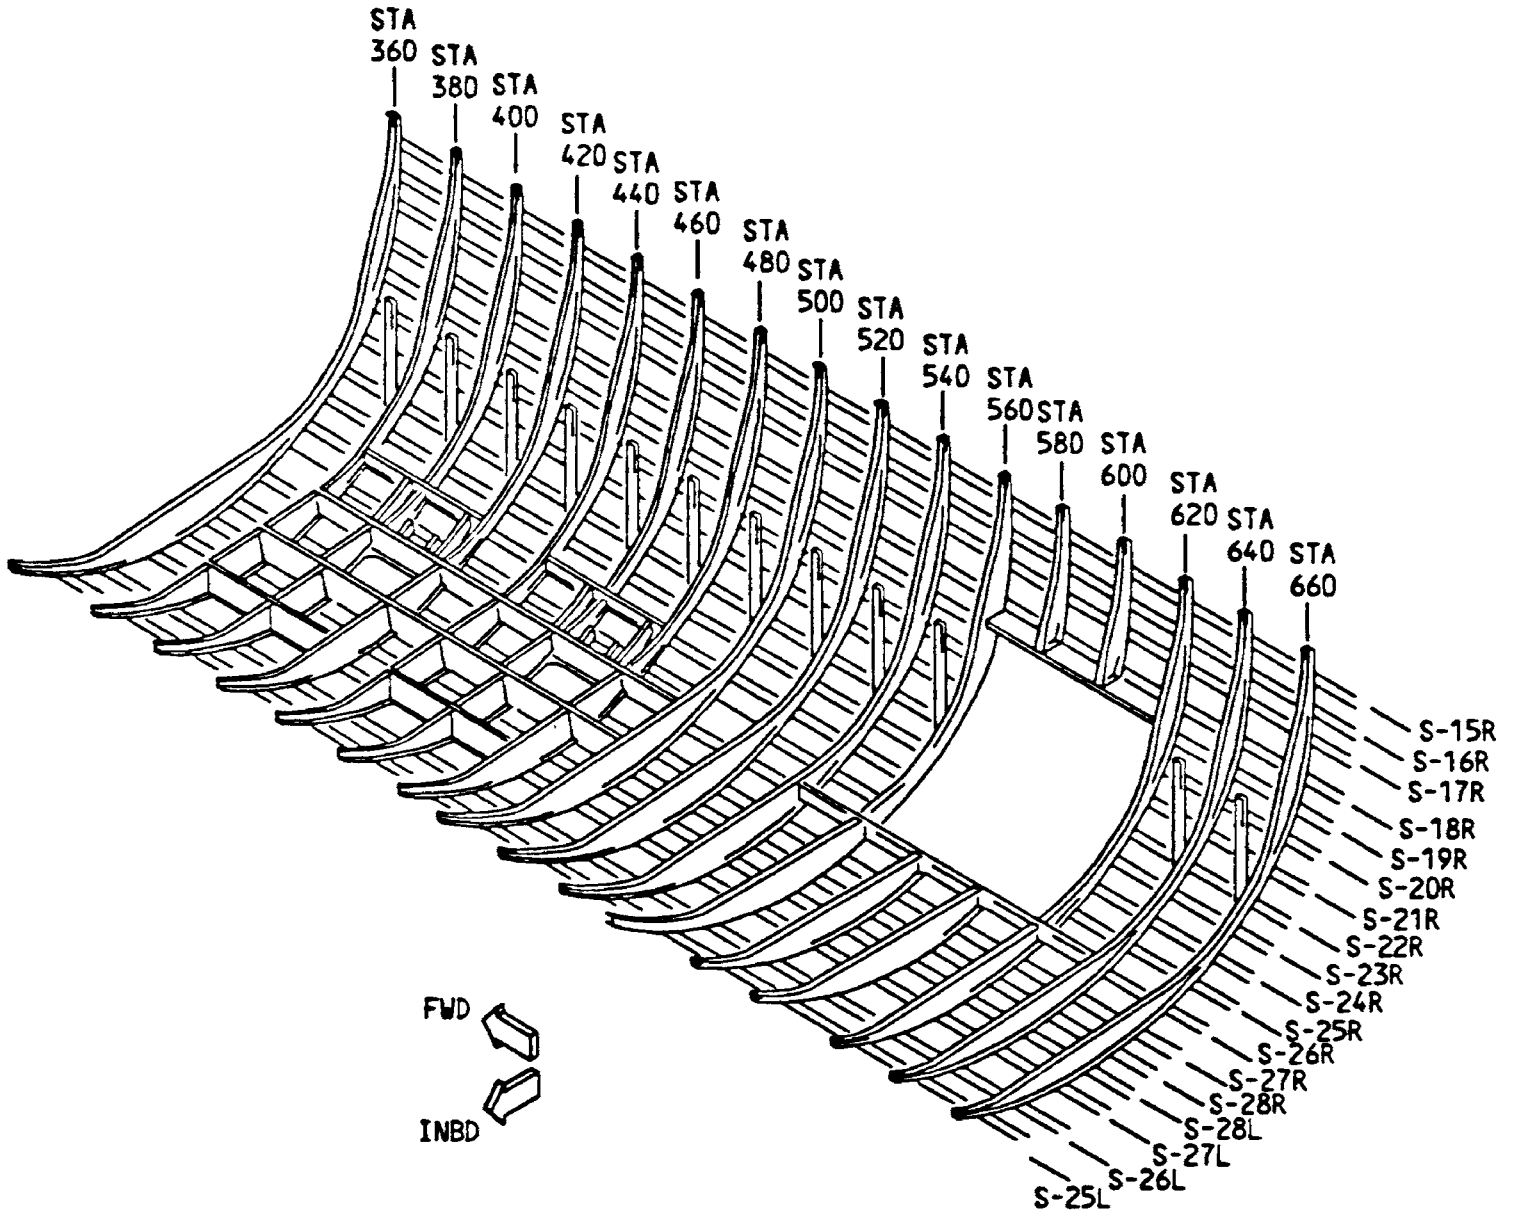
SECTION 43
BS 360 TO BS 660

DETAIL V
LEFT SIDE SHOWN RIGHT SIDE OPPOSITE
EXCEPT WITHOUT DOOR OPENING
