ZONES: 345  
 A/C NUMBER:  
 REV. DATE: 06/15/06  
 FREQUENCY: 1C  
 AD NUMBER 99-07-05

W/C NUMBER: 534I2701  
 DATE:  
 W/O:  
 JAC CODE:

INSPECT RH ELEVATOR ASSEMBLY

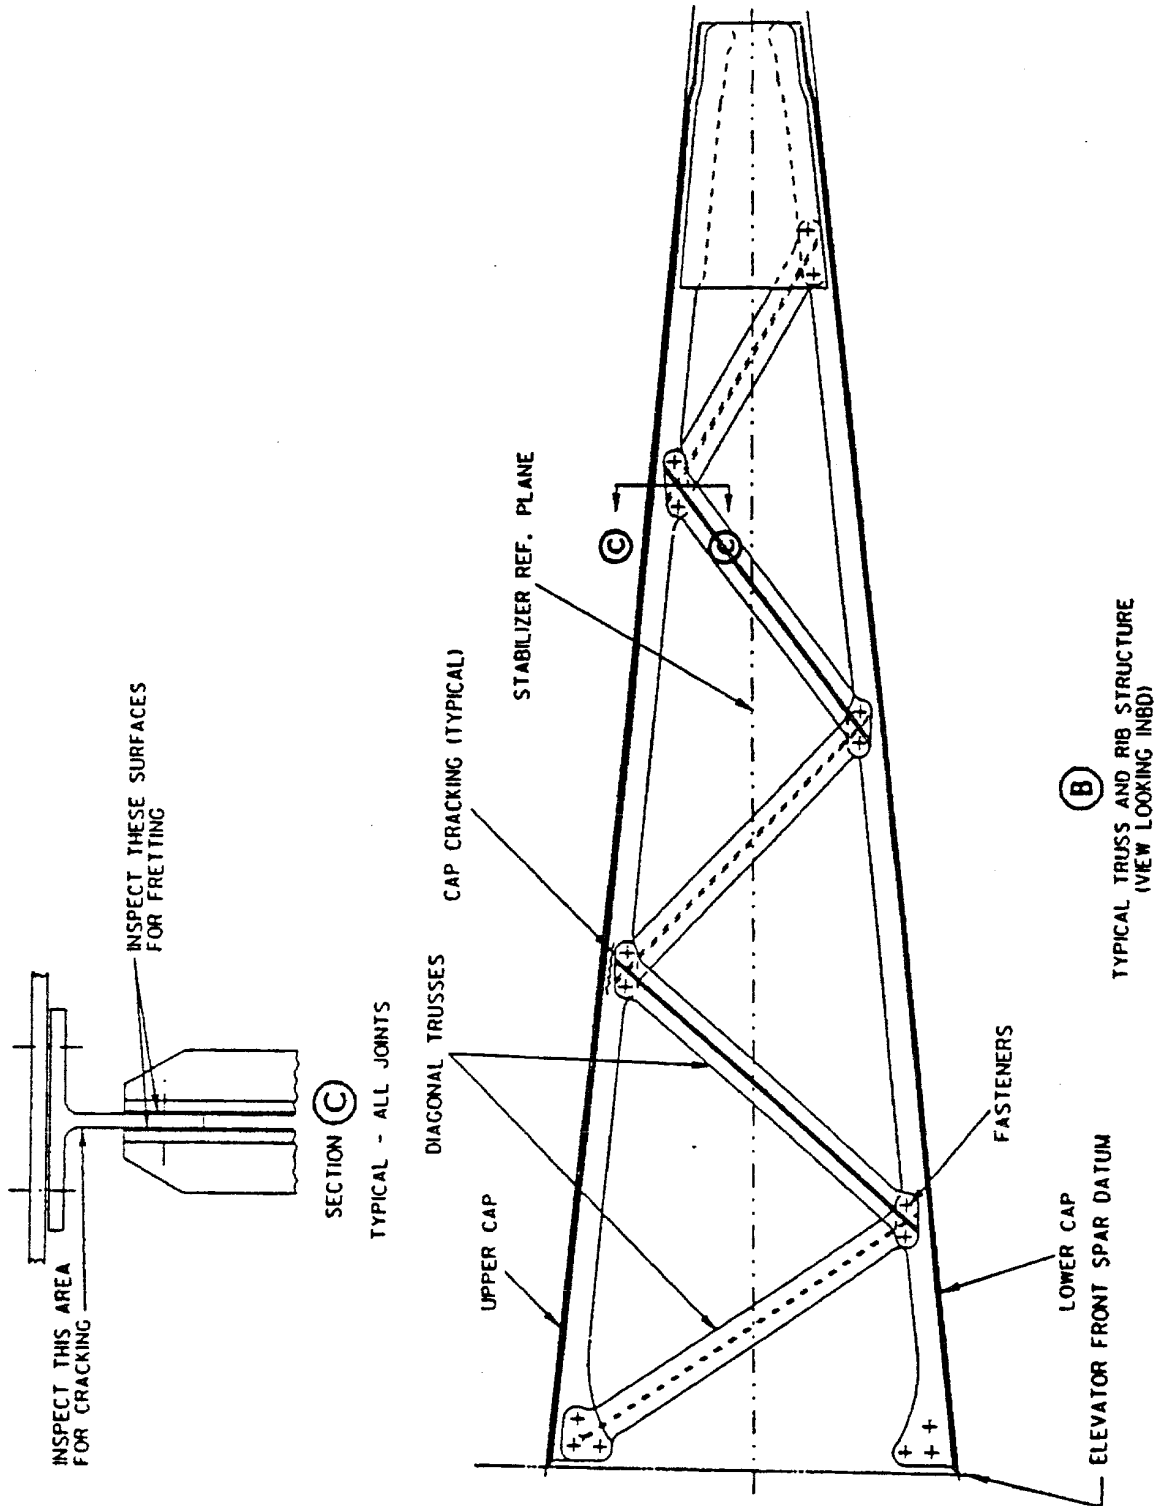
FIGURE 1

C PERFORM AN INTERNAL DETAILED VISUAL INSPECTION USING A BORESCOPE. ILLUMINATE INNER AREA OF ELEVATOR AND INSPECT ALL DIAGONAL TRUSS JOINTS FOR LOOSE OR SHEARED RIVETS, EVIDENCE OF FRETTING AT FAYING SURFACES, DAMAGE OR CRACKING OF UPPER AND LOWER CAPS, AND TRUSS BRACES (REF. FIGURE 1) BETWEEN E.S. 85.5 AND E.S. 248.33.

NOTE: IF DAMAGE IS FOUND, GENERATE NON-ROUTINE TO REPAIR THE TRUSS RIB STRUCTURE PER SECTION III OF E.O. L10-55AD-1793.
