ATA AIRLINES, INC.

ALTERNATE FLAP DRIVE GEARBOX SERVICING

W/C NUMBER: 317L2701 DATE:

ATA AIRLINES, INC. B737-800 FLEET

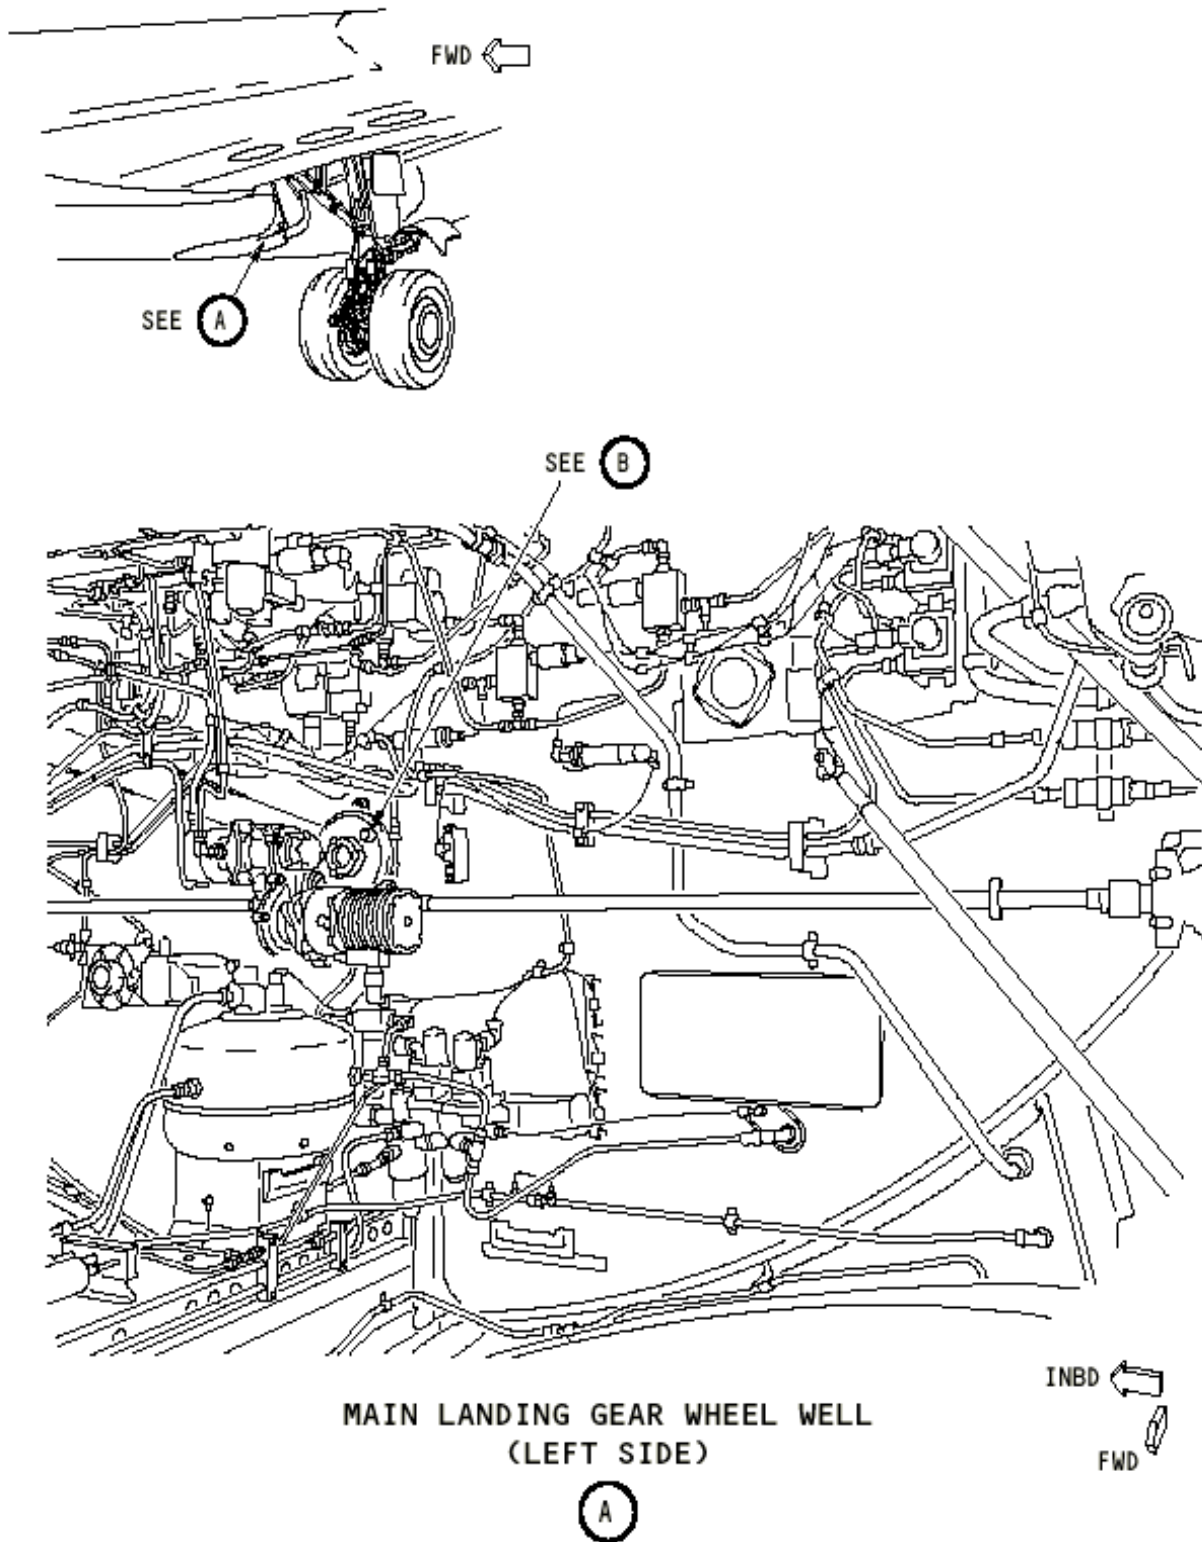
1. Trailing Edge Flap Electric Motor Servicing (Figure 1).

(1) Do a check of the fluid level in the flap electric motor:

(a) Remove the fill plug [181] and packing [182] from the fill port.

(b) Make sure the fluid is at the level of the fill port.

(c) If the fluid is not at the level of the fill port, fill the flap electric motor with fluid, MIL-H-5606 to the level of the fill port.

(d) Lubricate the new packing [182] with fluid.

(e) Install the fill plug [181] and new packing [182] in the fill port.

(f) Install lockwire on the fill plug [181].

Figures 1 and 2, AMM 27-51-00
