**ATA AIRLINES, INC.**

BS 900 - BS 1180, AREA ABOVE WING CENTER SECTION AND MLG WHEELWELLS PAGE 1 / 2

ZONES: 131 132 141 142 W/C NUMBER: 210I5306 DATE:  
A/C NUMBER: W/O:  
REV. DATE: 10/22/03 JAC CODE:  
FREQUENCY: S2C

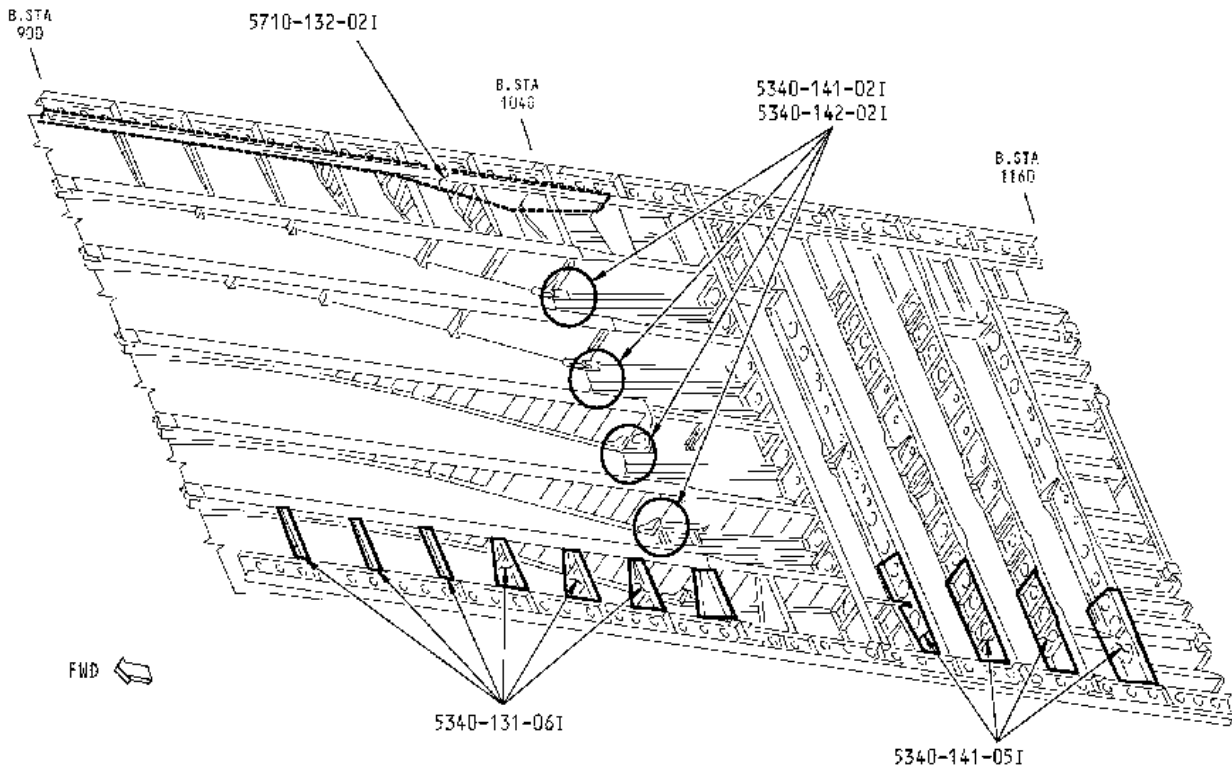
FIGURE 1

ILLUSTRATION REF. 1-10 BODY BELOW FLOOR (STA. 900 - 1160)

BS 900 – BS 1180  
INSPECTION AREAS

- | (1) Inspect area identified as 5340-141-02I and

| 5340-142-02I on figures 1 and 2.

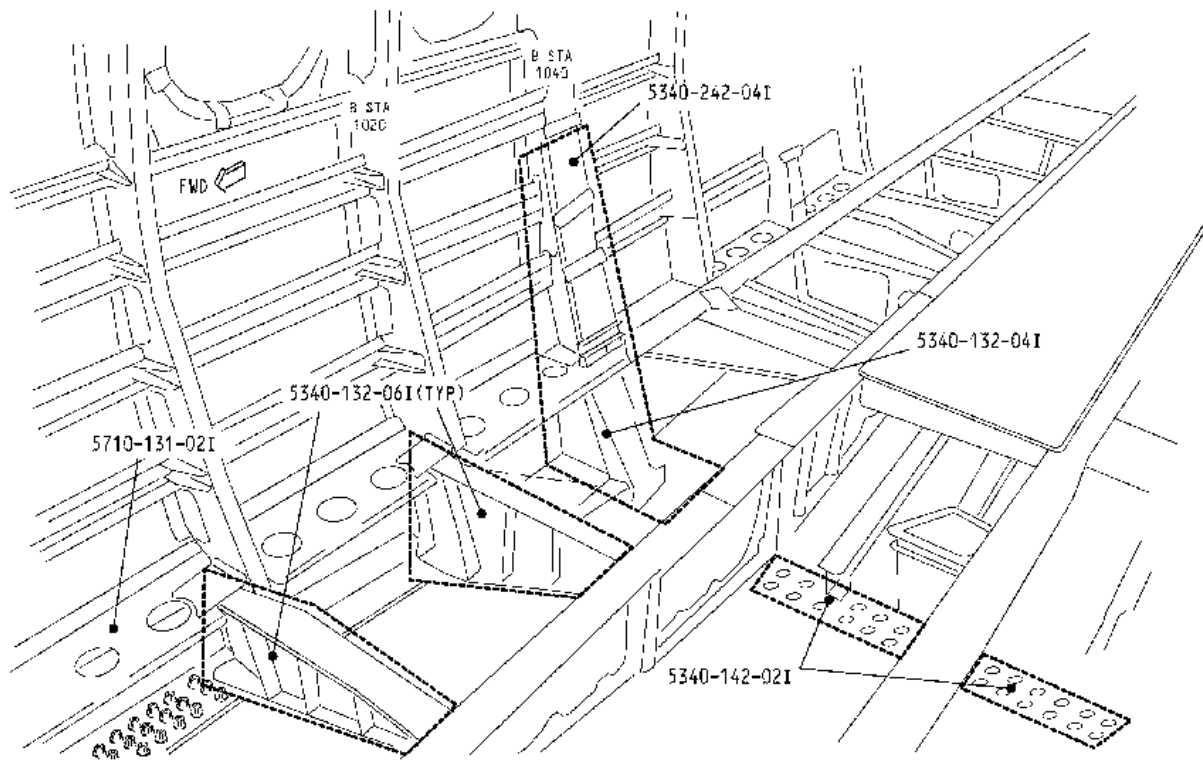
FIGURE 2

ILLUSTRATION REF. 1-12 OVER WING FRAME AND STUB BEAMS

BS 900 – BS 1180  
INSPECTION AREAS

(1) Inspect area identified as 5340-131-04I and 5340-132-04I on figures 2 and 3.
- |XXXX \_\_\_\_\_ D. Perform a Detailed Internal Inspection of the pressure deck in areas of attachments at BS 1040 (Zones 141, 142).

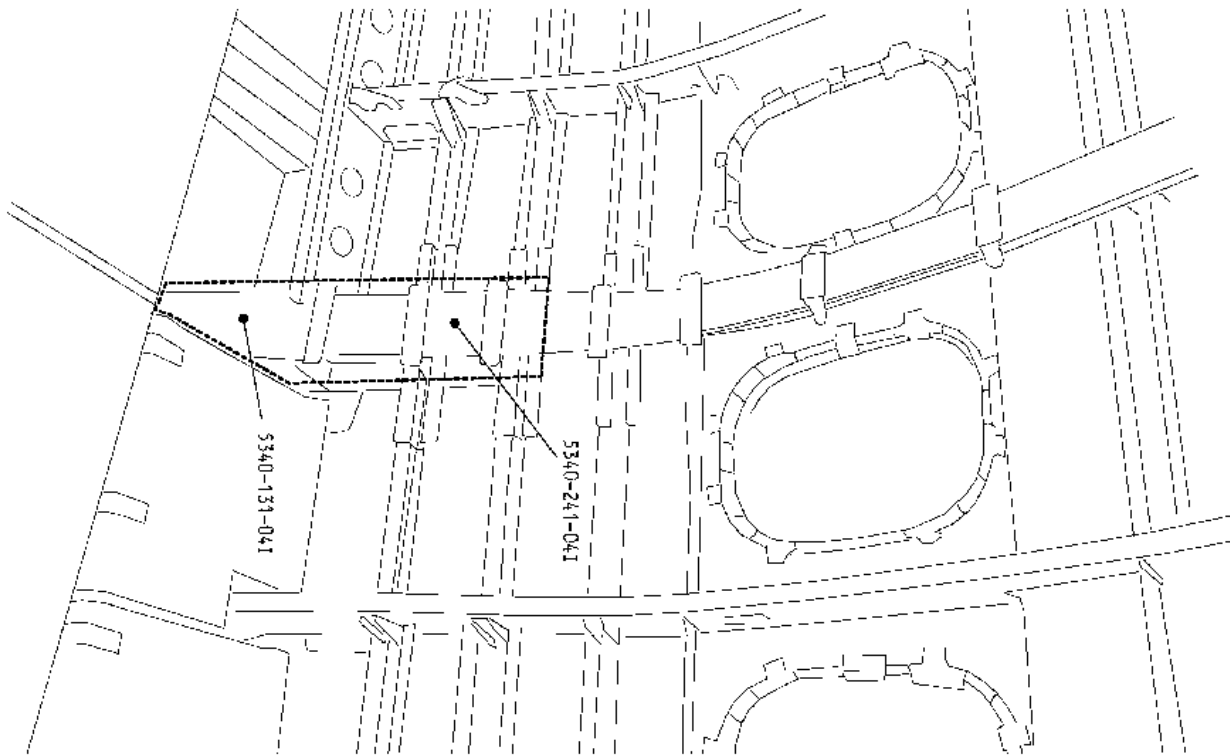
FIGURE 3

ILLUSTRATION REF. 1-13 BODY STATION 1040 BULKHEAD

BS 900 – BS 1180  
INSPECTION AREAS

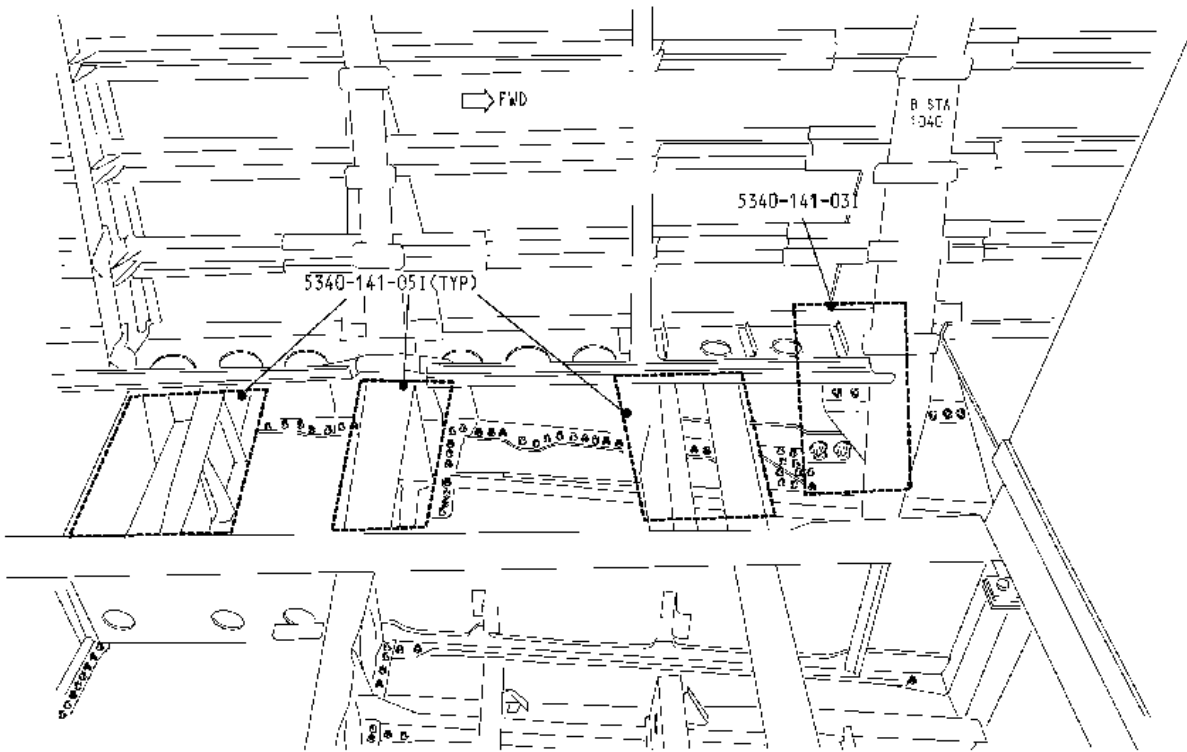
FIGURE 4

ILLUSTRATION REF. 1-18-1 BODY UNDER FLOOR ABOVE WHEEL WELL

BS 900 – BS 1180  
INSPECTION AREAS

- | (1) Inspect area identified as 5340-141-03I on

| figure 4.
