**ATA AIRLINES, INC.**

**GALLEY DRAIN OPERATIONAL CHECK**

**W/C NUMBER: 223M3801**    **DATE:**  
**W/O:**  
**JAC CODE:**

FORWARD AND AFT GALLEY DRAIN OPERATIONAL CHECK

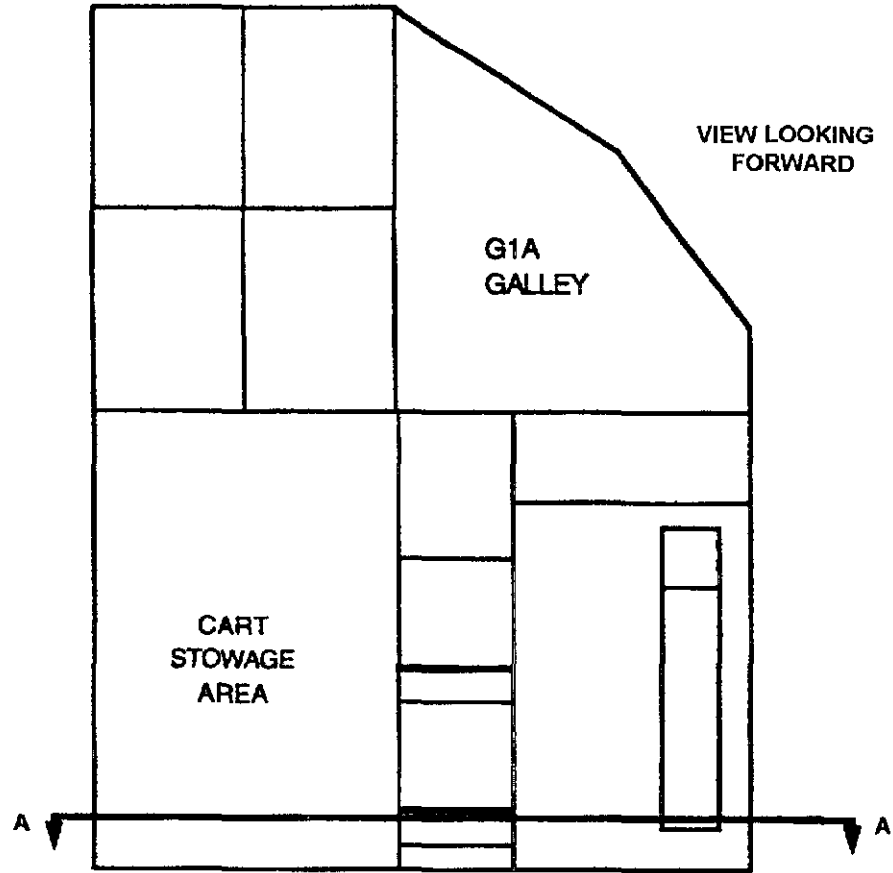
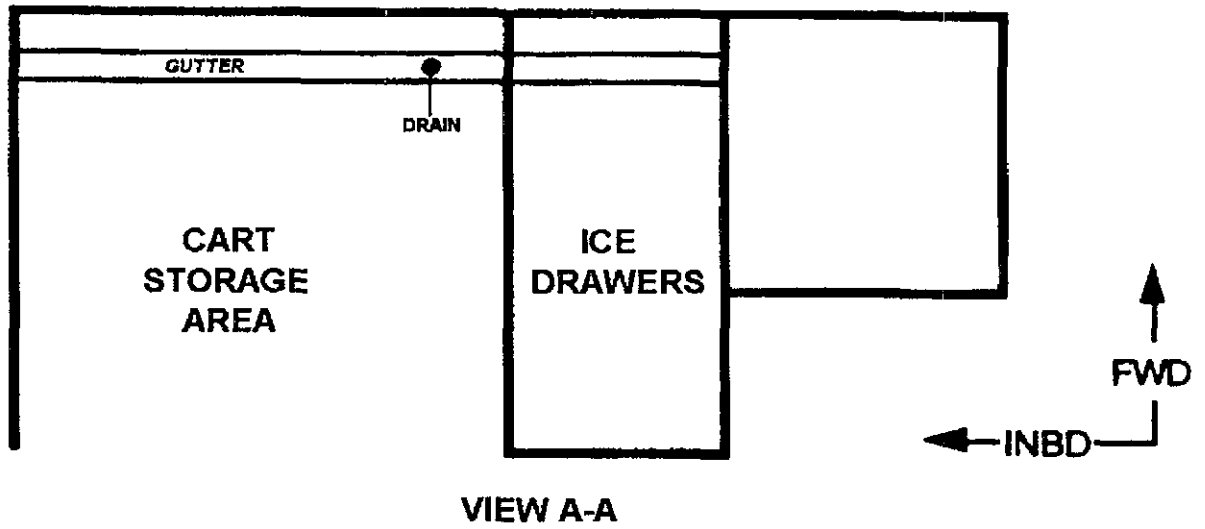
FIGURE 1

FORWARD (G1A)  
GALLEY DRAIN

1. PERFORM AN OPERATIONAL CHECK OF THE FORWARD (G1A) GALLEY FLOOR  
GUTTER AND DRAIN (REF. FIGURE 1).

- \_\_\_\_\_ XXXXX A. Remove beverage carts from the galley area.
- \_\_\_\_\_ XXXXX B. Check the galley floor gutter and drain screen for dirt and  
debris. Clean if necessary.
- \_\_\_\_\_ XXXXX C. Slowly pour a small amount (approximately 12 ounces) of  
mild hot water/vinegar solution into the gutter and verify  
the drain works properly. This can be confirmed by ensuring  
water flows freely from the forward exterior overboard  
drain mast.

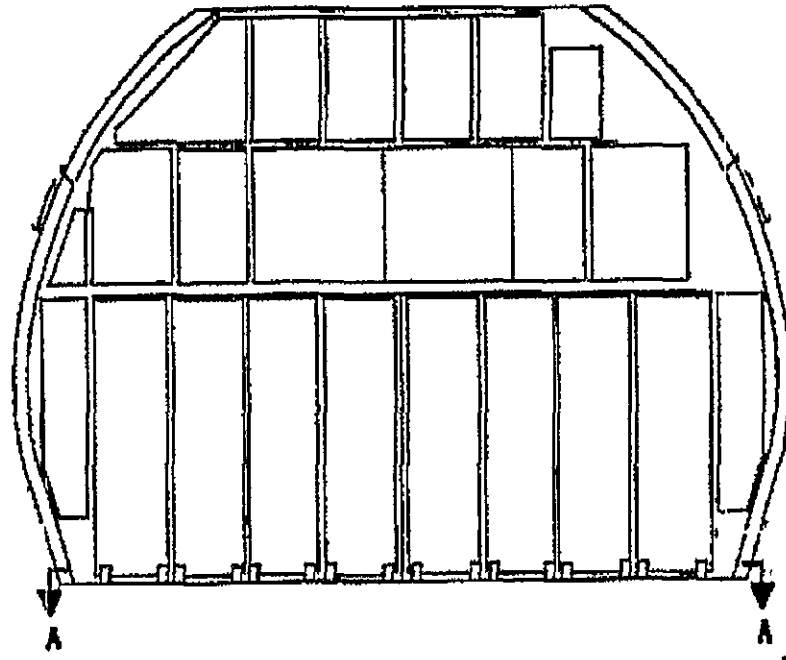
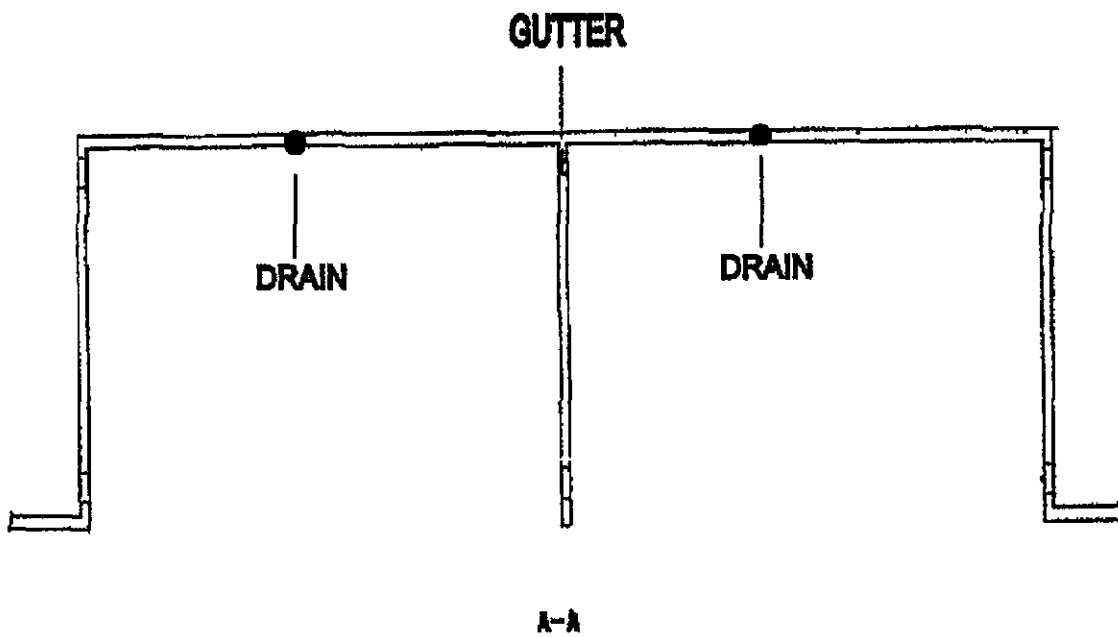
GALLEY 4B

A-A

2. PERFORM AN OPERATIONAL CHECK OF THE AFT (G4B) GALLEY FLOOR  
GUTTER AND DRAINS (REF. FIGURE 2).

- \_\_\_\_\_ XXXXX A. Remove beverage carts from the galley area.
- \_\_\_\_\_ XXXXX B. Check the G4B galley floor gutter and drain screens for  
dirt and debris. Clean if necessary.

NOTE: The G4B galley has (2) galley drains on the  
floor gutter.

\_\_\_\_\_ XXXXX C. Slowly pour a small amount (approximately 12 ounces) of mild hot water/vinegar solution into the gutters and verify the drains work properly. This can be confirmed by ensuring water flows freely from the aft exterior overboard drain mast.
