ZONES: 119
 A/C NUMBER:
 REV. DATE: 06/16/04
 FREQUENCY: D
 AD NUMBER 2004-09-28

W/C NUMBER: 510I5303 DATE:
 W/O:
 JAC CODE:

INSPECT AREA ABOVE NLG COMPARTMENT (PRESSURE DECK)

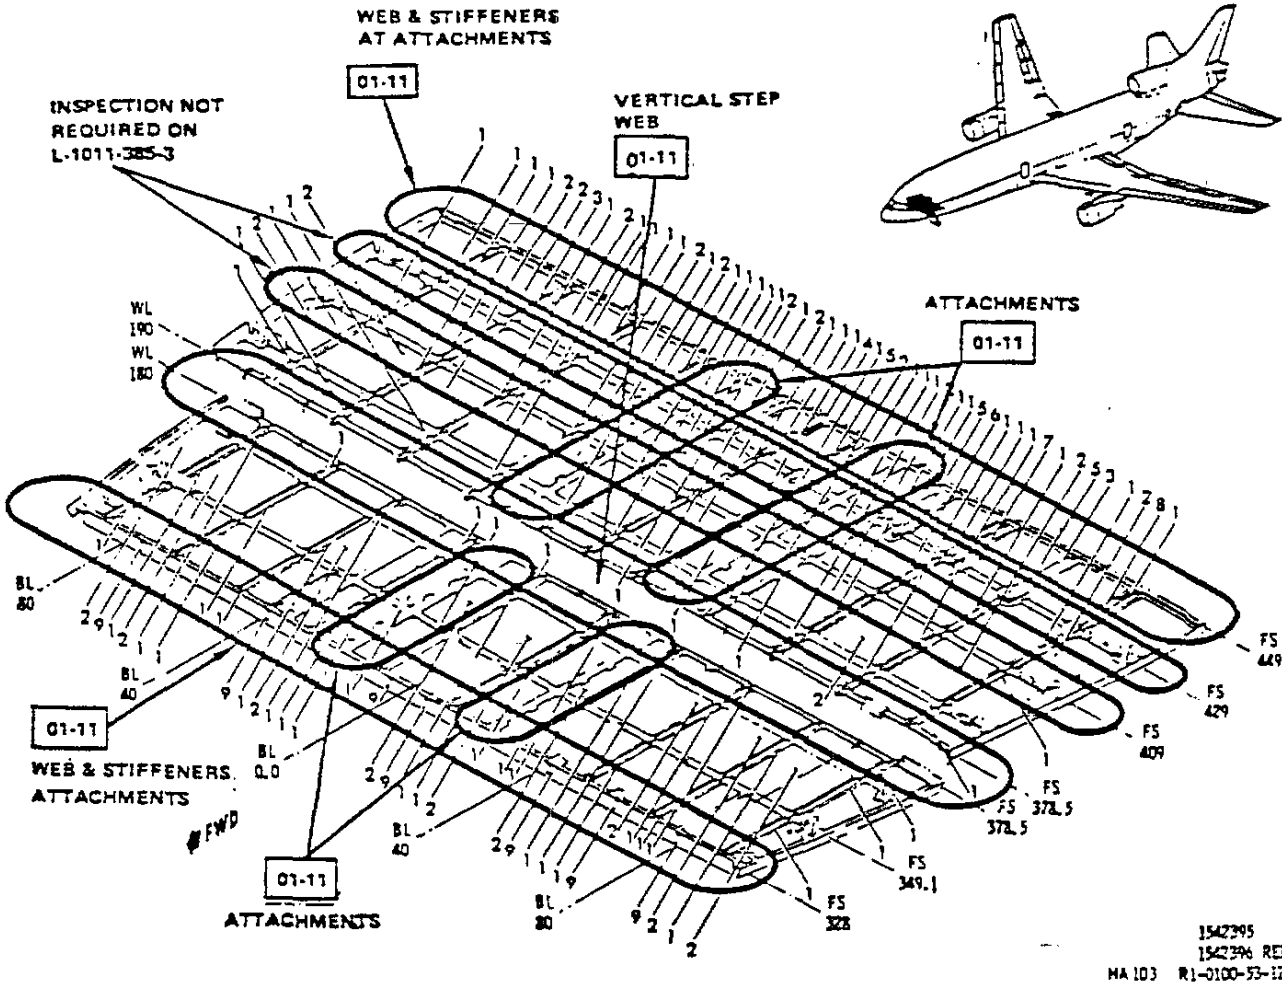
**NOSE LANDING GEAR WHEEL WELL, ELECTRONICS SERVICE CENTER
AND HEAT EXCHANGER COMPARTMENT
ATA CHAPTER 53 STRUCTURAL SIGNIFICANT ITEMS (SSI'S)
FIGURE 1**

- A DETAIL INSPECT WEB AND STIFFENERS AT ATTACHMENTS TO FS 328 BULKHEAD.
- B VERTICAL STEP WEB, FS 378 BETWEEN WL 180 AND WL 190; WEB AND DOUBLERS ADJACENT TO DUCT CUTOUTS.

C NOSE WHEEL WELL PRESSURE DECK FLOOR BEAMS FS 389, 409.
PARTICULAR ATTENTION TO JUNCTION OF THE BEAM LOWER CAPS AND
BEAM WEB (NOT REQUIRED ON L1011-385-3).

D AT ATTACHMENTS TO BL 22 L AND R VERTICAL WEBS, FS 328 AND
FS 449.

E WEB AND STIFFENERS AT ATTACHMENTS TO FS 449 BULKHEAD.
(SSI 53-01-11)
(SEE FIGURE 1)

- 1 ENSURE DRAIN HOLES OR GAPS ARE NOT OBSTRUCTED.
- 2 FOR CRACKS, PERMANENT DEFORMATION, OR CORROSION TO PRIMARY STRUCTURE (REF. SRM CHAPTER 51); INITIATE A SERVICE DIFFICULTY REPORT (SDR) (REF. GMM, CHAPTERS 4 AND 12) AND RECORD THE ASSOCIATED NON ROUTINE CARD NUMBERS BELOW.
